TALGO, INCORPORATED

NTSB Accident Number: RRD-18MR001

Proposed findings in relation to the behavior of the railroad rolling stock involved and recommendations for improved safety in connection with the derailment of Amtrak Train 501, DuPont, Washington, Dec. 18, 2017

FINAL SUBMISSION

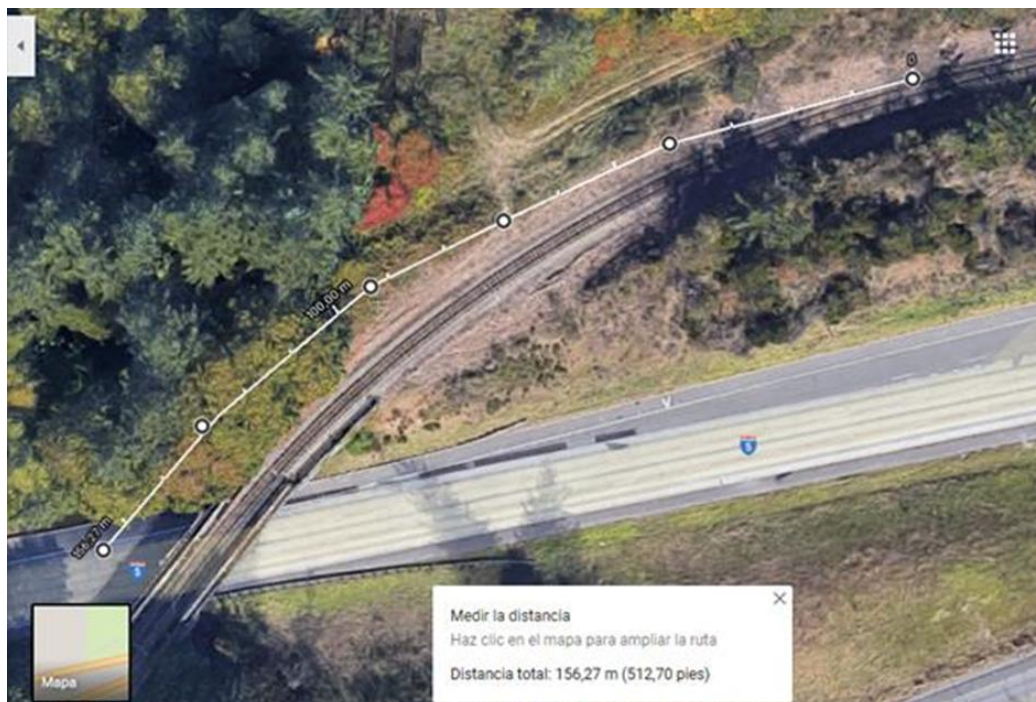
Figure 11 Approximate route of the first group

Once the locomotive returned to a vertical position, the five cars in this group (power, C1, C2, dining and bistro) continued to follow it, descending on the right slope of the fill and finally stopping with the locomotive on the highway. When the locomotive hit the pavement, due to the unstable AAR couplers between it and the Talgo consist, the power car turned counterclockwise (as viewed from above) and separated from it.

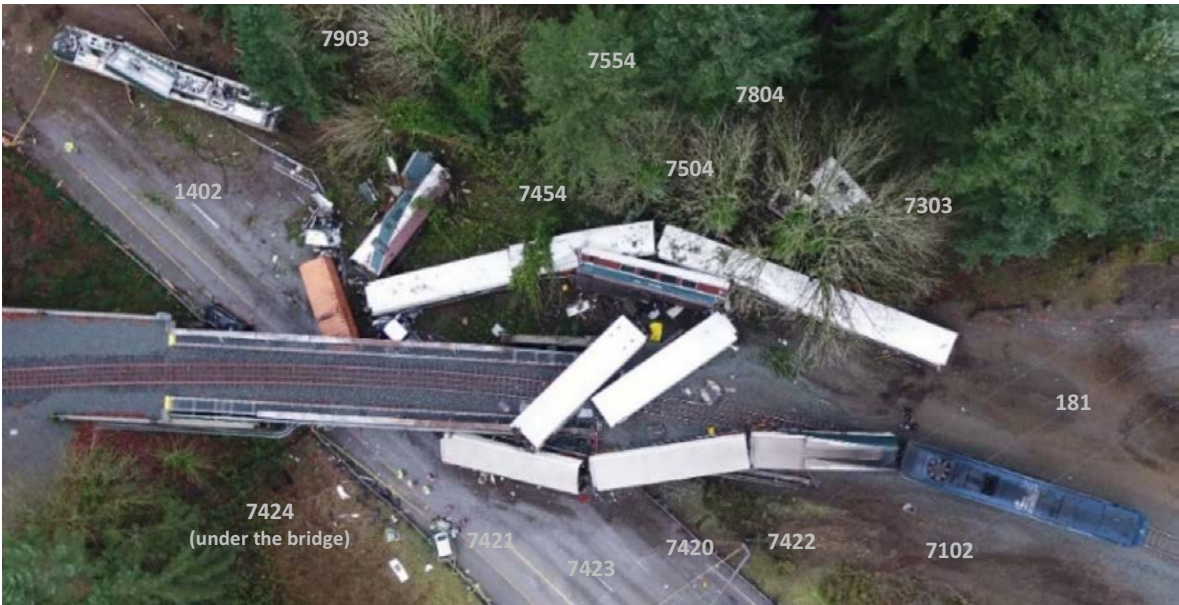
Figure 12 Final location of the equipment after the accident

C7 7421, which lead this group, passed the point of derailment without derailing and remained on the track until forces from C6 7420, which had rotated, caused it to derail to the left of the track, falling down the subgrade onto C4 7424, by now lying overturned on I-5. At this point a truck hauling an ISO container on a chassis and traveling south on the highway impacted the C4 7424 (and scratched C7 7421). The truck pushed C4 7424 under the bridge and moved C7 7421 in the same direction, coming to rest beyond the bridge. The rolling assembly on C5 7423 remained attached, with one of its wheels hitting the right side of C7 7421, now below it. The C7 7421 truck (RRG-0032) separated from the car, falling on the right side of I-5. C8 7420 then derailed, being pulled by C7 7421. Only one end of baggage car 7102 (and all four axles of the rear locomotive 181) remained on the track.

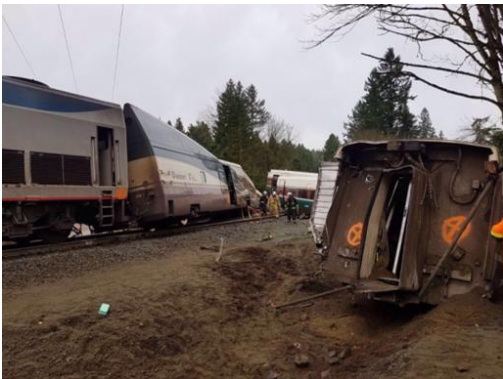
Only locomotive 161 (at left) and rear end of baggage car 7102 (center) remain on the track

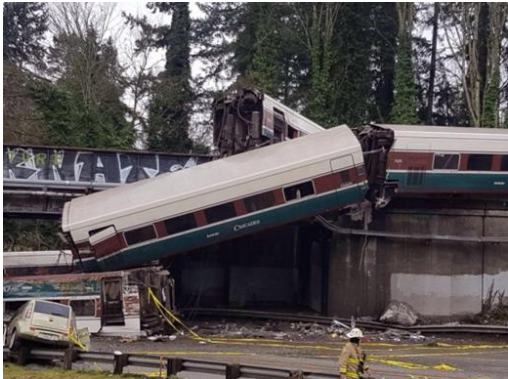
C7 7421 (center) rests on C4 7424 (upside down under the bridge). A wheel from C5 7323 (above it) has impacted the right side of C7

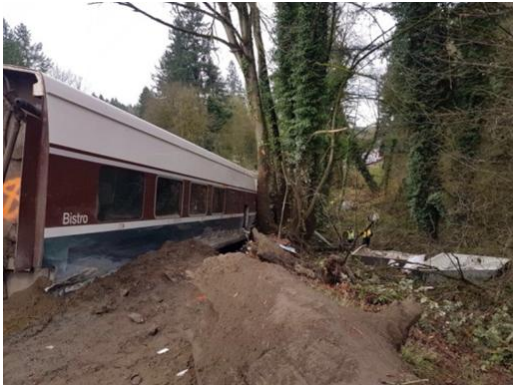
Bistro 7303 has followed the locomotive into the woods

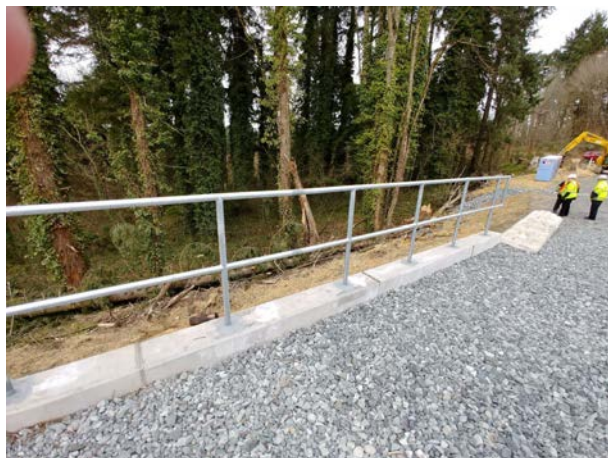
Figure 14 Height difference track-wooded area (1)

The railroad runs parallel to a highway, Interstate 5 (I-5) prior to the curve where the accident took place. In this section trains run for about ten miles at the relatively high speed of 79 mph up to MP 19.9, where there is sharp curve (of about 720 foot radius) that diverts the railroad from its parallel orientation along I-5 and takes it across that highway on an overpass. The presence of this overpass (and the “bridge dump” fill approaching it) and the height difference between the track and the wooded area aggravated the consequences compared to an accident in an area without these features.

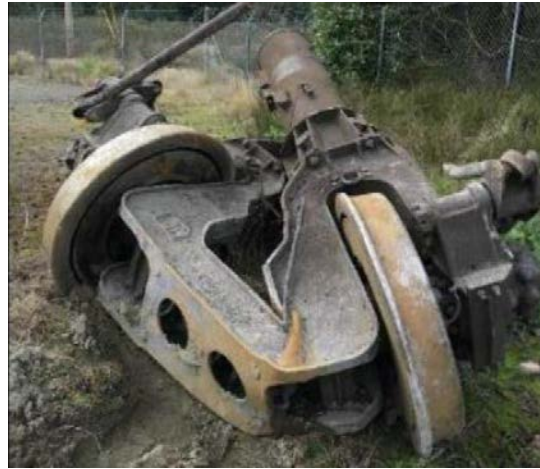
Figure 37 Deformed rolling assembly, made of 1/2 in. steel plate

It is, however, not clear how much securement would have been required to retain the rolling assemblies under the unknown accelerations and forces experienced at DuPont. Figure 37 provides an idea of the forces involved in the accident.

To increase the safety level of the rolling assembly attachment, Talgo proposes the addition of new straps to increase the retention capability beyond the FRA requirement. This modification is discussed in Section 5.

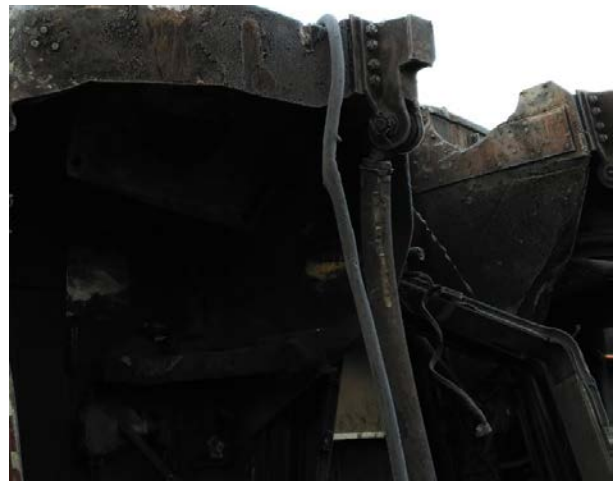
Figure 40 bistro 7303\ weight bearer bar buckling

Under the loads indicated in CFR the most critical condition is the buckling failure of the bars. This condition was apparent in several cars such as diner 7804, bistro 7303 and C5 7423. This effect is shown in Figure 39 to 41, where no failures of attachments are detected but severe deformations of suspension tower supports did occur. These deformations show that the forces produced during the accident greatly exceed the 100,000 pounds required by the current regulation.

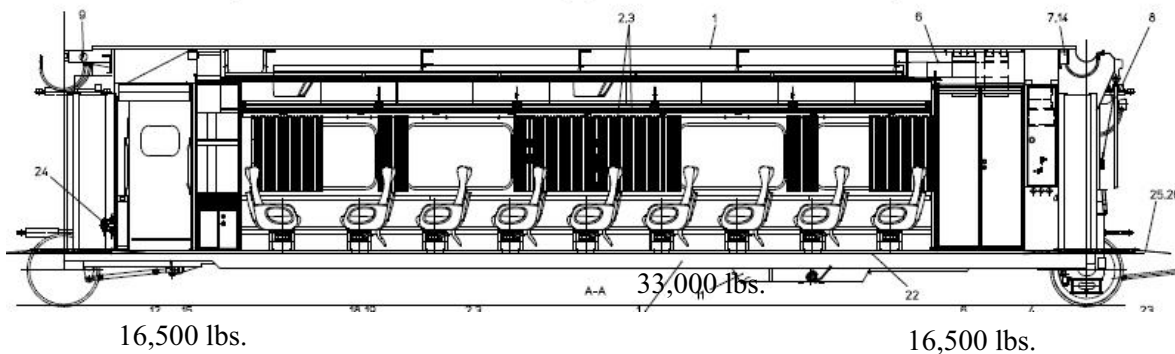
Figure 42 Load distribution

The structure to which the weight bearer bars are attached can carry a vertical tensile load of 150 kip at each support, 300 kip total. The weight of a passenger car is about 33,000 pounds, and thus the weight at each end is about 16,500 pounds.

Assuming that for some reason one weight bearer bar has failed and only the remaining bar is left to carry the entire weight of the suspended end of one car, the safety factor of the weight bearer bar under the weight of the car is greater than 9 (150 kips / 16.5 kips). Thus the weight bearer bar system is very safe, having both a very high safety factor and redundancy.

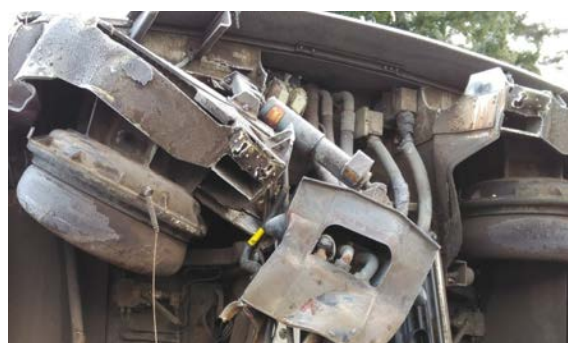
Figure 44 C7 7421 tear off detail

In some cars the aluminum plate where the weight bearer bars were attached had been torn off from the tower support. This failure was caused by very high forces as can be inferred from Figure 43 and 44, where the car body structure was severely deformed by these vertical loads.

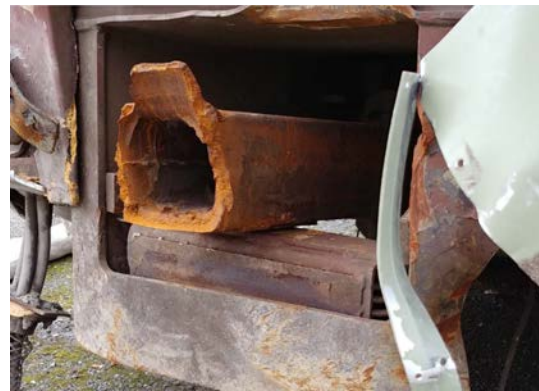
Figure 46 Power car 7903. AAR coupler (2)

The couplers on Talgo end cars are Type H Tightlock couplers in accordance with AAR (now APTA) standards (Talgo Technical Specification ET-0213). This coupler on power car 7903 was broken due to the forces produced when the buff forces (produced by the decelerating locomotive) caused lateral forces that rotated power car 7903. Post-accident inspections reveal deformations consistent with torsional and bending loads in the power car and the locomotive. Figures 45 and 46 show torsional and bending deformations on the power car coupler. Figure 47 and 48 show the torsion effects on locomotive coupler.

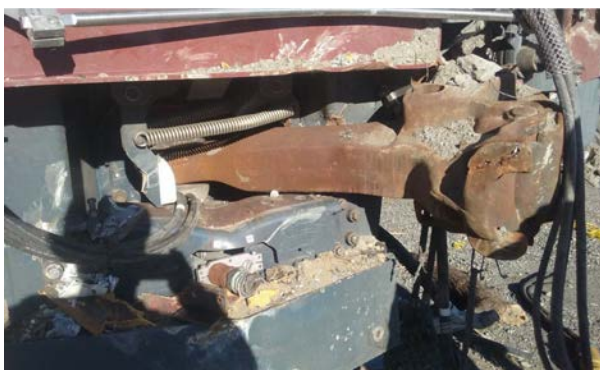
Figure 47 Loco 1402. AAR coupler (1)

The unstable pinned connection between the locomotive’s coupler and its draft gear yoke is evident in Figure 47. The result was that under heavy buff loading the coupler moved far to the right, displacing the front end of power car 7903 in that direction and allowing C1 7454 to push the rear end of that car to the left, rotating it 90 degrees clockwise (as seen from above) and into its final position.

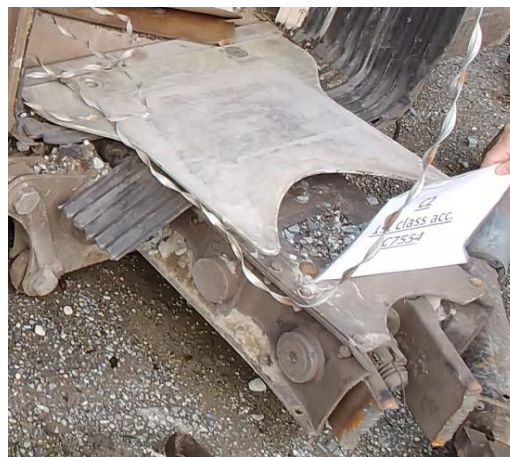
Figure 50 C2 7554. Coupler detail suspended end

Articulated connections were subjected to various types of loads depending on the car to which they were attached. The articulated joint between power car 7903 and C1 7454 was broken due to the rotation of the power car described in 2.4.5 above. For the connections between C1 7454, C2 7554, diner 7803 and bistro 7303, the couplers were subjected mainly to compressive forces, and it was necessary to cut off the bolted supports to release the cars.

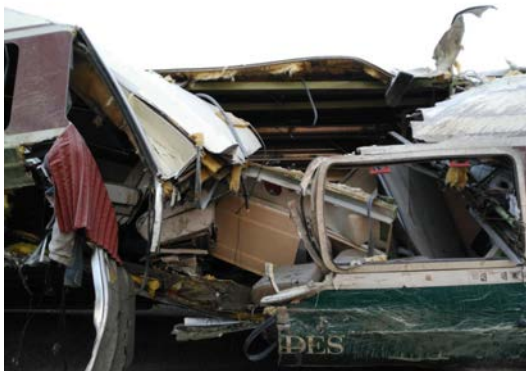
Figure 54 C3 7504. Side impact evidence (2)

According to the accident sequence described in 1.2, C3 7504 received a high speed side impact against the overpass approach fill retaining wall, causing extensive damage at that point (and possible immediately following this collision). As can be seen in Figures 53 through 56 below, this extensive damage could not have been produced by the truck that detached from C6 7422, three cars to the rear, but it could have easily been produced by impact with the concrete wall. One block from this wall, which was partially demolished by the impact for the train, is visible immediately to the left of the detached truck in Figure 56. All three deceased passengers were in this car.

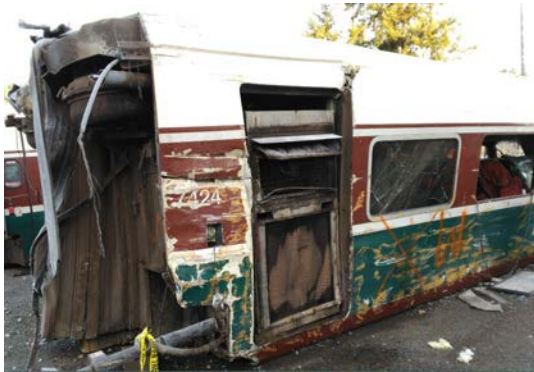
Figure 57 C4 7424. Side impact evidence (1)

During the accident sequence, C4 7424 was subjected to much more severe side and roof impacts than those required by the CFR. The car fell onto its roof under dynamic, not the “quasi static” conditions of 49 CFR 238.215, and then, while it was resting on its roof and supporting some additional weight from C7 7421, substantially increasing the vertical load, it was struck on the left side by the combination tractor semitrailer that was southbound on I-5, the condition anticipated by 238.217 for an otherwise

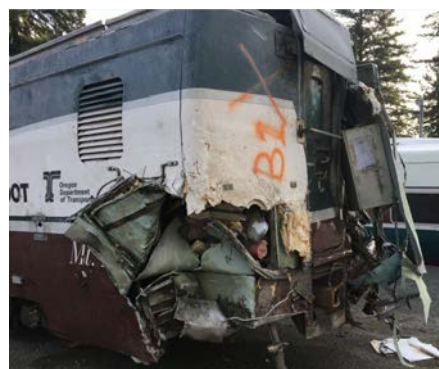
Figure 62 7903 Power car. End detail (2)

While severe damage to the end fairing of power car 7103 was apparent during the inspection at JBLM, the steel structure that forms the collision posts was found to be undamaged. (See Figures 61 and 62)

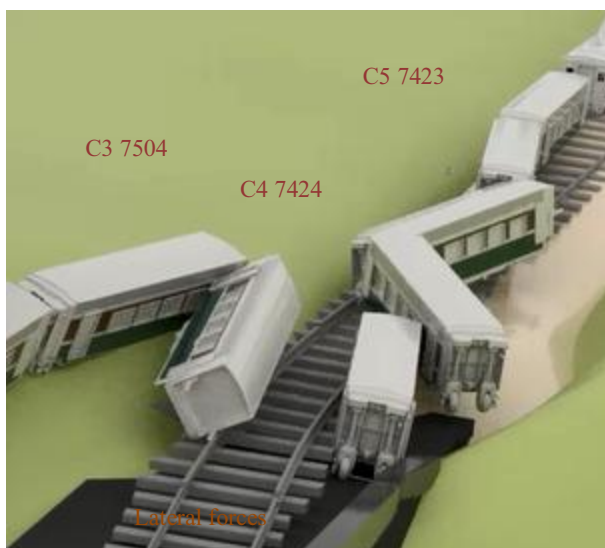
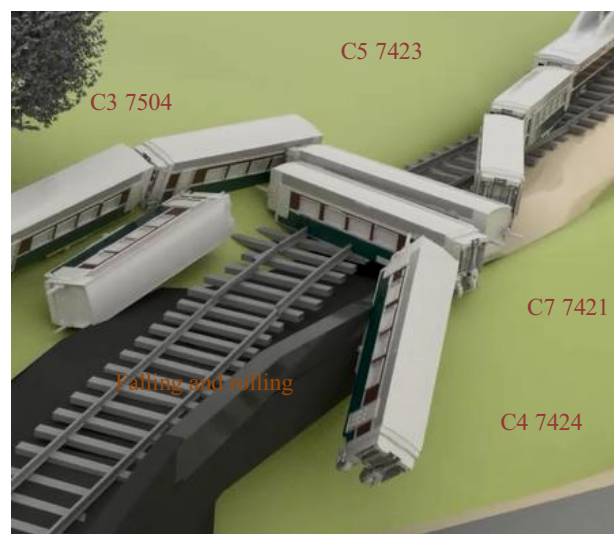
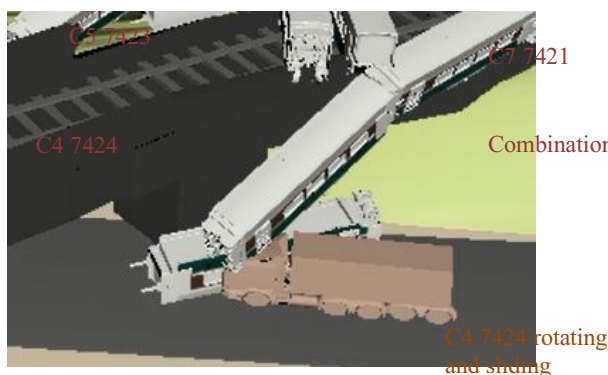
Following the same sequence described in 1.2, C4 7424 also was subject to lateral forces, breaking its connections with the adjacent cars and the shared trucks. At this point the car slid over the track and collided with the overpass, severely damaging the right side (Figure 89). After this collision, the car fell, rolling to its left, onto the highway and landing its roof. At that point the tractor-semi-trailer combination vehicle impacted it on its right side. The car came to rest under the bridge after rotating and sliding due to its own inertia and the collision with the truck.

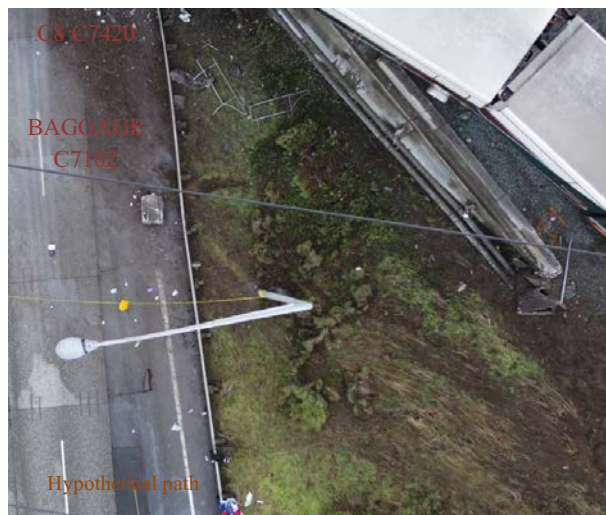
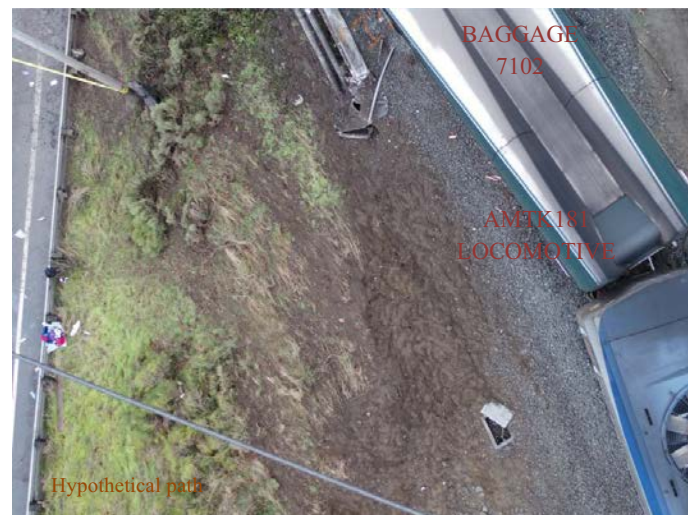
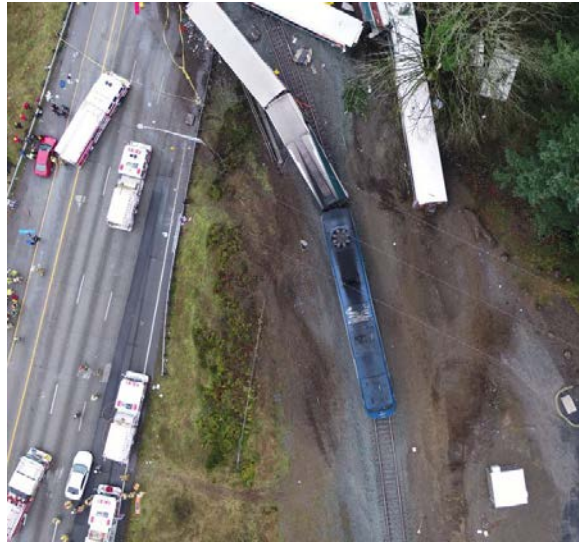
If the C4 had slid along the embankment, there would have been damage to the surrounding infrastructure, but no damage was evident on the guard rail or street light (yellow circles in Figure 91). Thus the marks on the embankment visible in the pictures below were likely there before the accident, requiring rejection of this hypothesis.

Based on the above Talgo believes the probable path of derailment of C4 was a fall from the overpass approach fill instead of a slide along the embankment. Car inspection showed that the right tower support (Figure 94) was extensively deformed, damage consistent with a vertical impact with the highway.

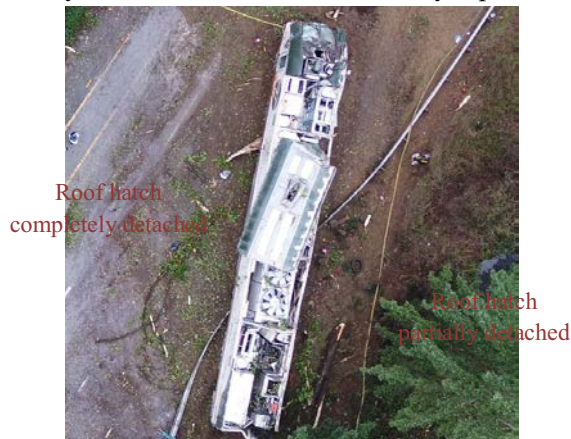
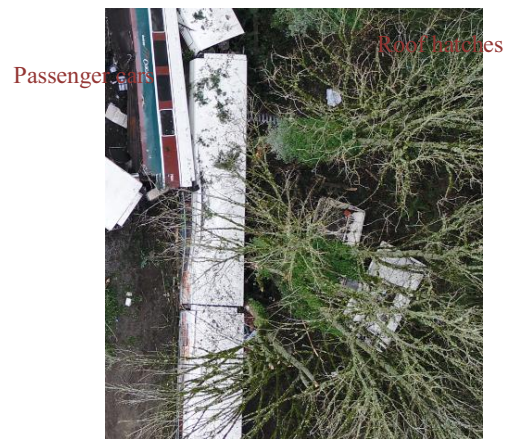
According to accident sequence the locomotive did not suffer a heavy lateral impact, but some components such as roof hatches were detached from it. These components, as others involved in the collision, are potentially dangerous to the train crew, nearby drivers or even passengers on the train, all of whom could be hit by these hatches. They have not been addresses in any report we have seen to date.

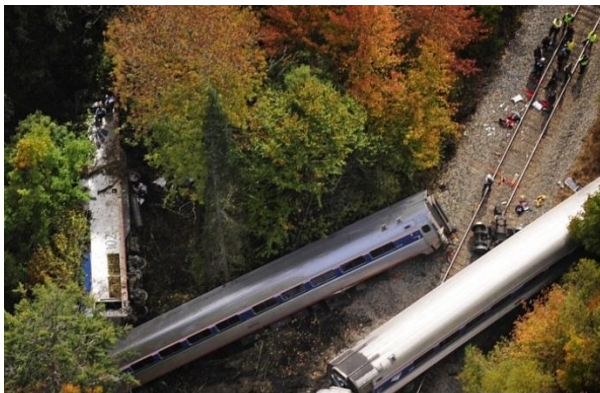
Figure 102 Overall view (1) Northfield

At the time of this accident the train was running at its MAS of 59 mph. The derailment was caused by a large rock slide. The locomotive and four coaches derailed. The locomotive and the first car slid down a steep embankment. In this incident at least two couplers were broken, causing a large lateral displacement of the decoupled cars. Those cars did not foul an adjacent track only because there was none. As can be seen in Figure 102, at least one truck detached. The failed connections between cars are also clearly visible.

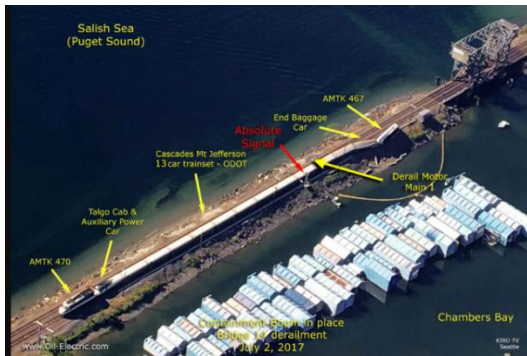
Figure 104: Overall view

The locomotive turned onto its right side and may have gone into the water but the Talgo train configuration resulted in the entire trainset working together to keep it from rolling more than it did.

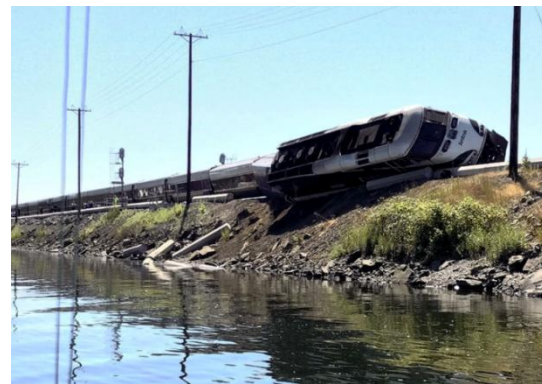
Figure 107: Locomotive supported by the train

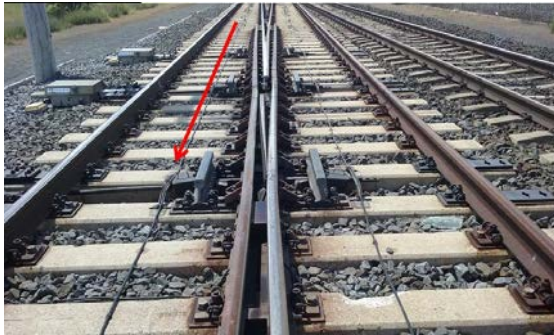
Figure 108 Track detail (1)

This incident involved a very high speed (Series S112) train set. One wheel of this train impacted a broken rail in a swing nose frog causing the derailment of that axle at 167 mph. The train stopped 1.614 miles [2598 m] from the point of derailment, with the entire trainset on the track except for the one derailed truck. The final investigation showed that the cause of the incident was the broken rail. No injuries and only minor material damage resulted; no plastic deformation on truck frames or tower supports were found.

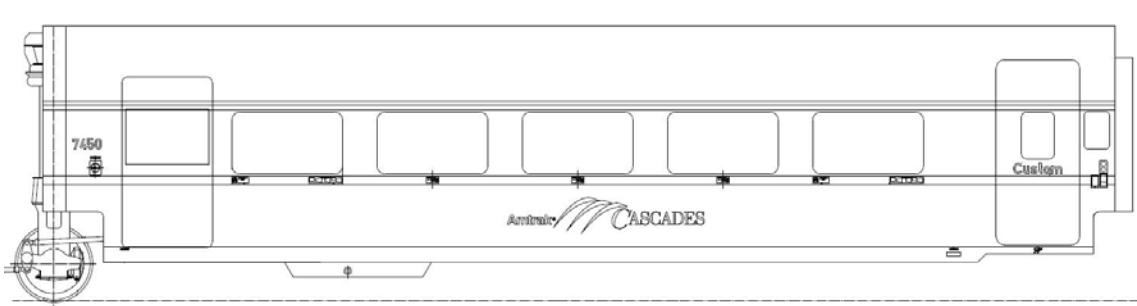
Figure 112 Current location of instruction signage

The emergency windows of several cars were used for egress after the derailment, but several passengers and first responders reported that the instructions were confusing. On the exterior, under each side window there is a sign which indicates the proper way to use the window in case of emergency. Currently the non-emergency windows are marked at the bottom with the text “*EMERGENCY Talgo Window removal. All windows are breakable using a sharp, heavy object*”. Emergency windows have two different pictograms at the bottom: “*Emergency exit*” and “*Emergency instructions*”. Talgo propose to change the pictograms as follows:

1. The pictograms should be placed at the quarter points as shown in 3. (Currently the pictograms for emergency windows are located at the ends of the windows as shown in Figure 112.)

2. Each text should refer only to one window. The text should indicate “*EMERGENCY. This window is breakable using a sharp, heavy object*”.
The pictograms for emergency windows should not be changed.
